## Case Study

## Floated roof - Oil Storage Tank

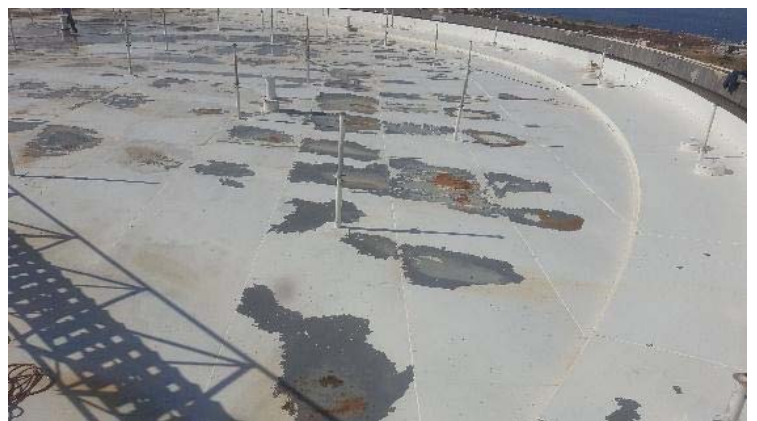
***Floated roof initial condition***

Surface preparations required abrasive blasting, but new regulations prohibit such treatments during maintenance, so a new solution needed to be found. Storage tanks located on shore and coal ash from electricity power plant chimneys located near the tanks, accelerate the corrosion process and increase the frequency of maintenance. Such a project takes time and has high costs

The surface of the float roof was cleaned by high pressure water jetting (over 500 bar) to remove old paint and loose metal. Once the area was dry, **Corrizon Base** was applied by airless spray over the old paint.

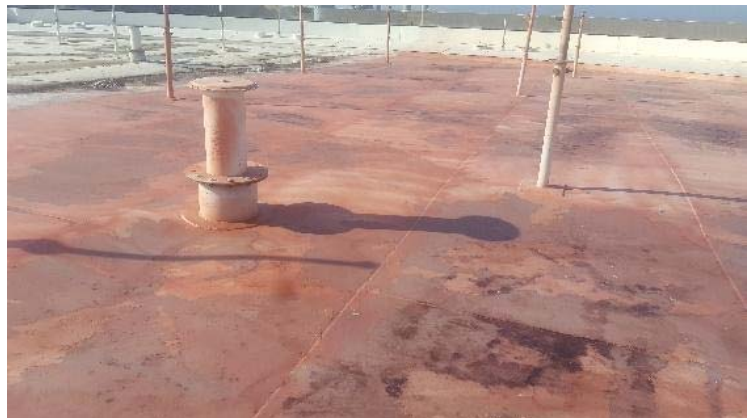
The required WFT was fifty microns. **Corrizon Base** has white-off white color (the old top paint was white).

***Pigmented Corrizon Base***

A pigment was added to the product to verify that all surfaces had been coated. After 24 hours, a new polyurethane top paint layer was applied to complete the customer paint system requirements.

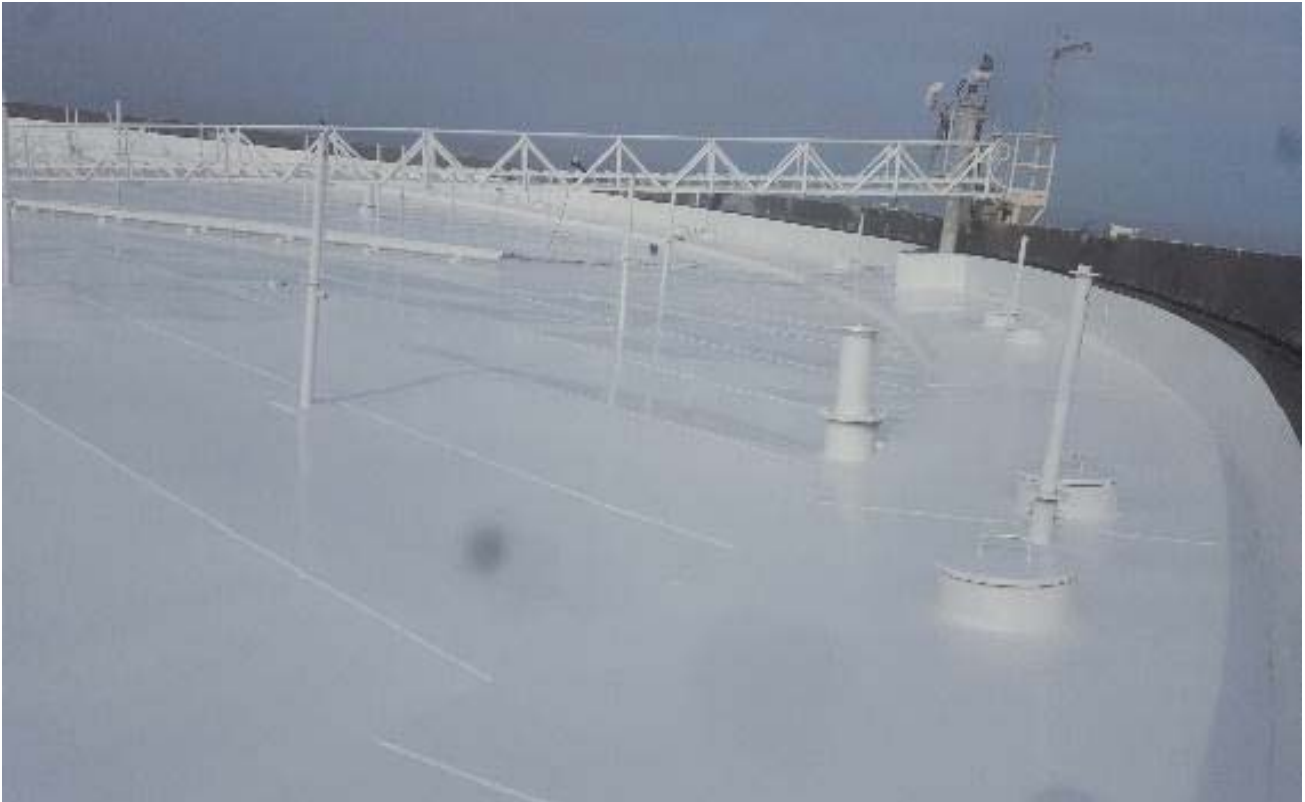
After over a year, the floated roof is in excellent condition. There is no sign of rust or paint lamination. Also, the DFT remains the same and the adhesion is very good.

***Floated roof appearance after polyurethane top paint***
