## Case Study

## QUEEN MARY Primary Hull Renovation

# Queen Mary

## – Primary Hull Renovation

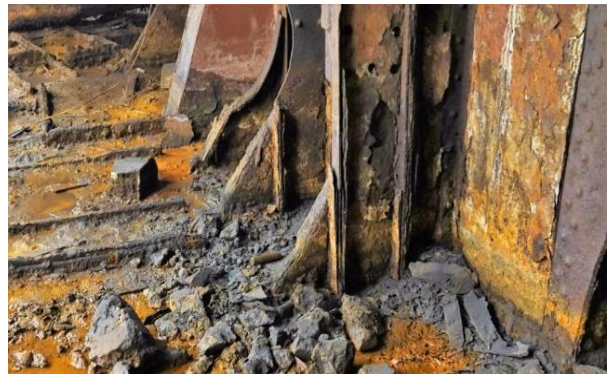
**Corroded steel debris inside**

Rather than use abrasive blasting to prepare the outdoor surfaces on the vessel, high pressure water cleaning was used to remove all loose paint, mill scale and rust.

Nearly **80 tons of corroded steel debris** was cleared out.

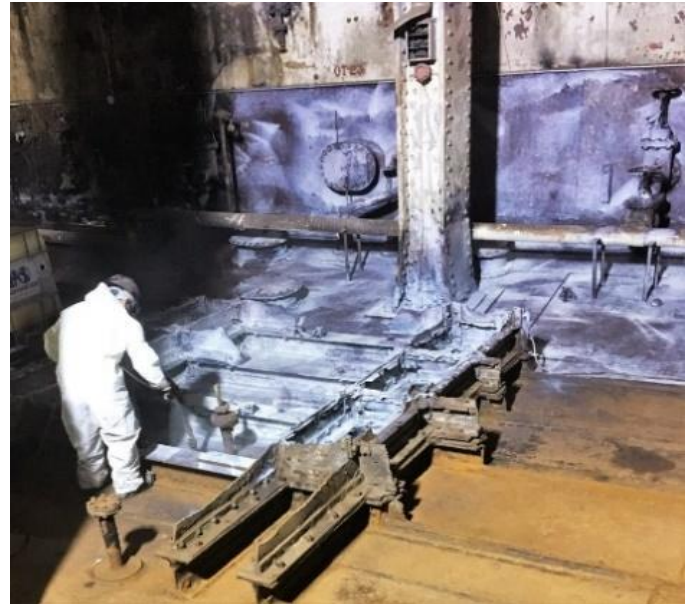
**Corrizon Base application inside the boiler room**

The water pressure used was 500 bars with super duty rotary head nozzles to remove rust, scale, disbanded metal and dirt. In areas that couldn't be pressure washed, the men removed the steel debris by manual rotary brushing.

Finally, after degreasing, the crew used an airless spray to apply a single layer (1-2 mm) of **Corrizon Base**.

After 24 hours , ship was ready for the chosen top coat of paint and no additional treatments.

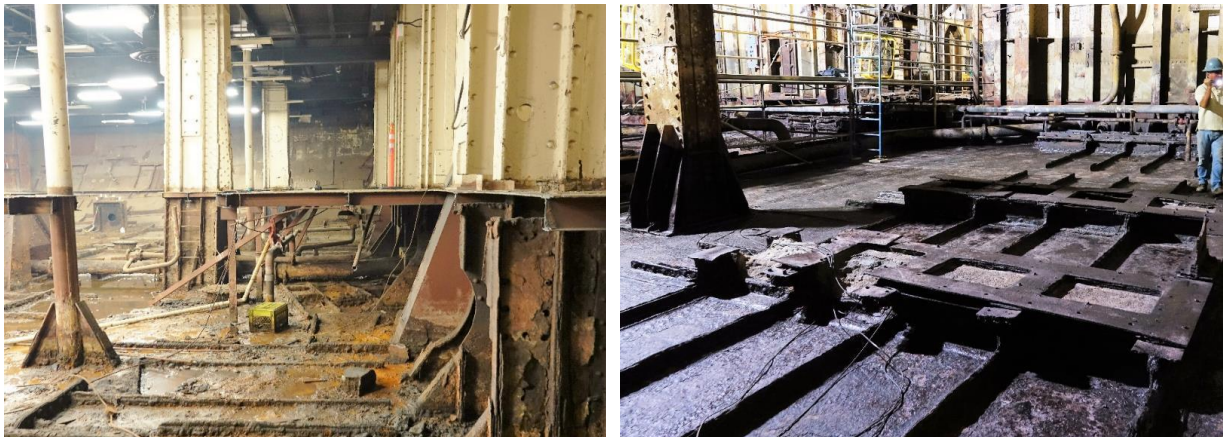
After a year, the painted areas are in excellent condition. There is no sign of rust or paint lamination. Also, the DFT remains the same and the adhesion is very good.

**Before**

**After**
