IKA Report No. 22-1340

## Salt Spray and Weight Loss Tests

Green I.C.P.S

06.06.2022

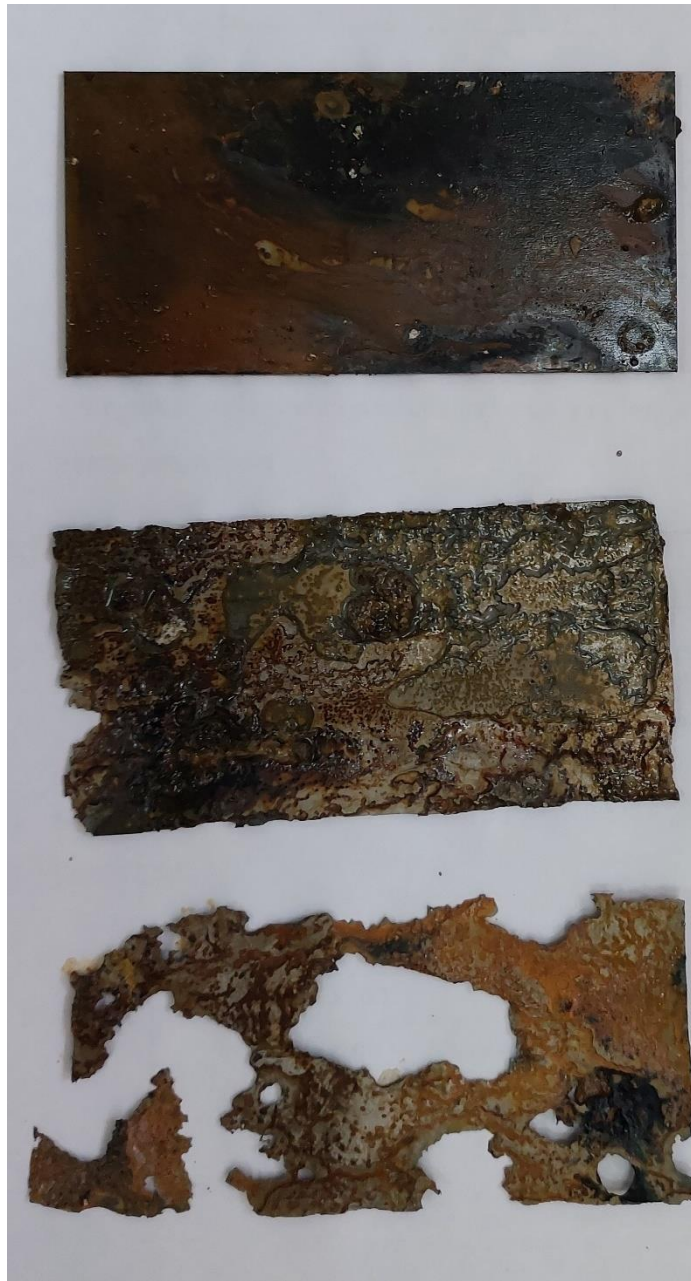
Figure 2

Group I – coupons after 10000 hours of SST and mass loss test  
(CB) "Corrizon Base" treated  
(U) Untreatment  
(Ref) Not treated - reference

Afterwards, the coupons were immersed, dried and weighed for 4 time, until the mass loss was 0.05gr or less. Figures No. 1-7 present the coupons after the mass loss test. Carbon steel and galvanized coupons "CB" remain flat with dull gray appearance, similar to the appearance of the reference coupons "Ref". Coupons " Untreated " exhibits rough surface with concaves and pits due to corrosive attack (general corrosion). Table No. 3 summarizes the results of the mass loss test.

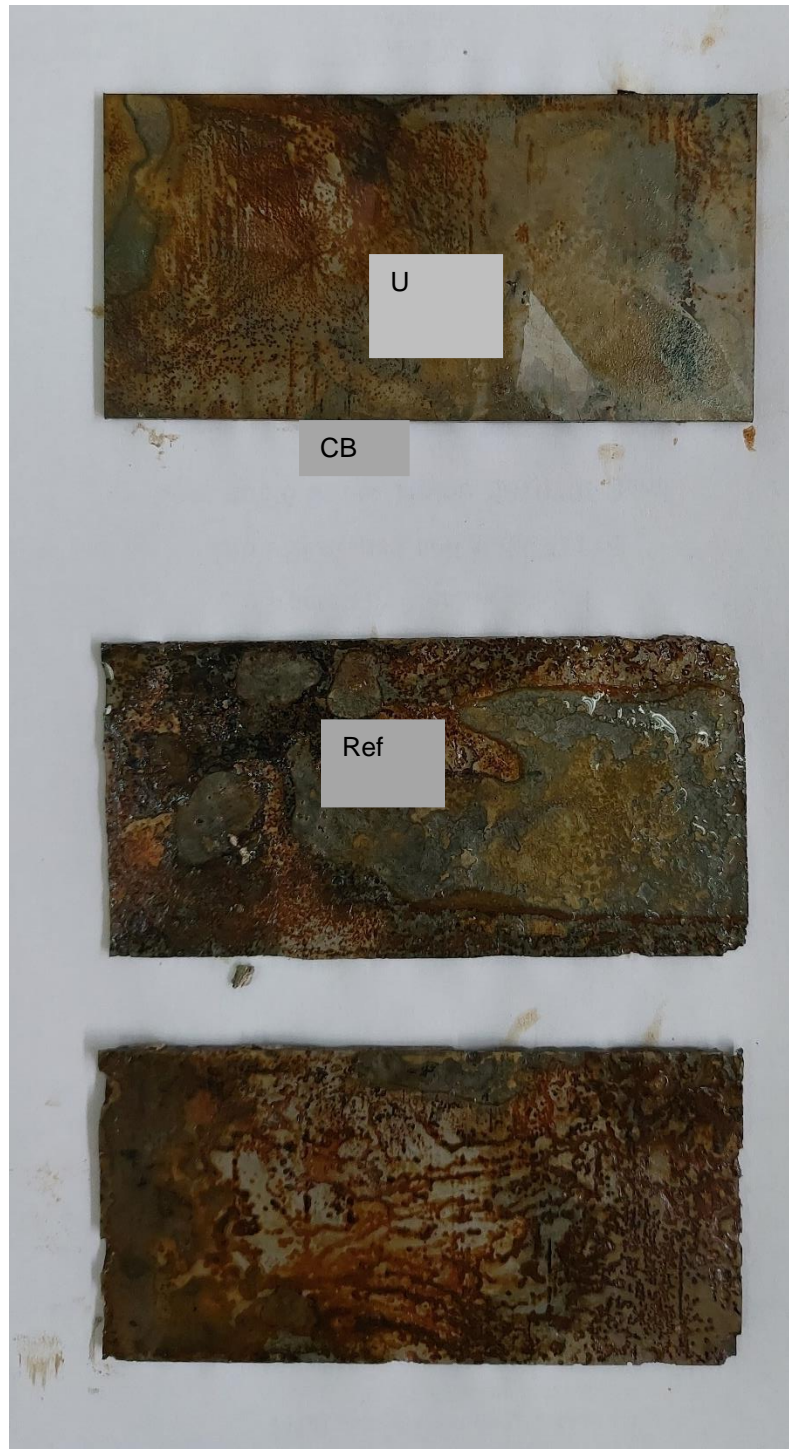
Figure 3

Group II – coupons after 10000 hours of SST and mass loss test

(CB)"Corrizon Base" treated

(U) Untreatment

(Ref) Not treated - reference

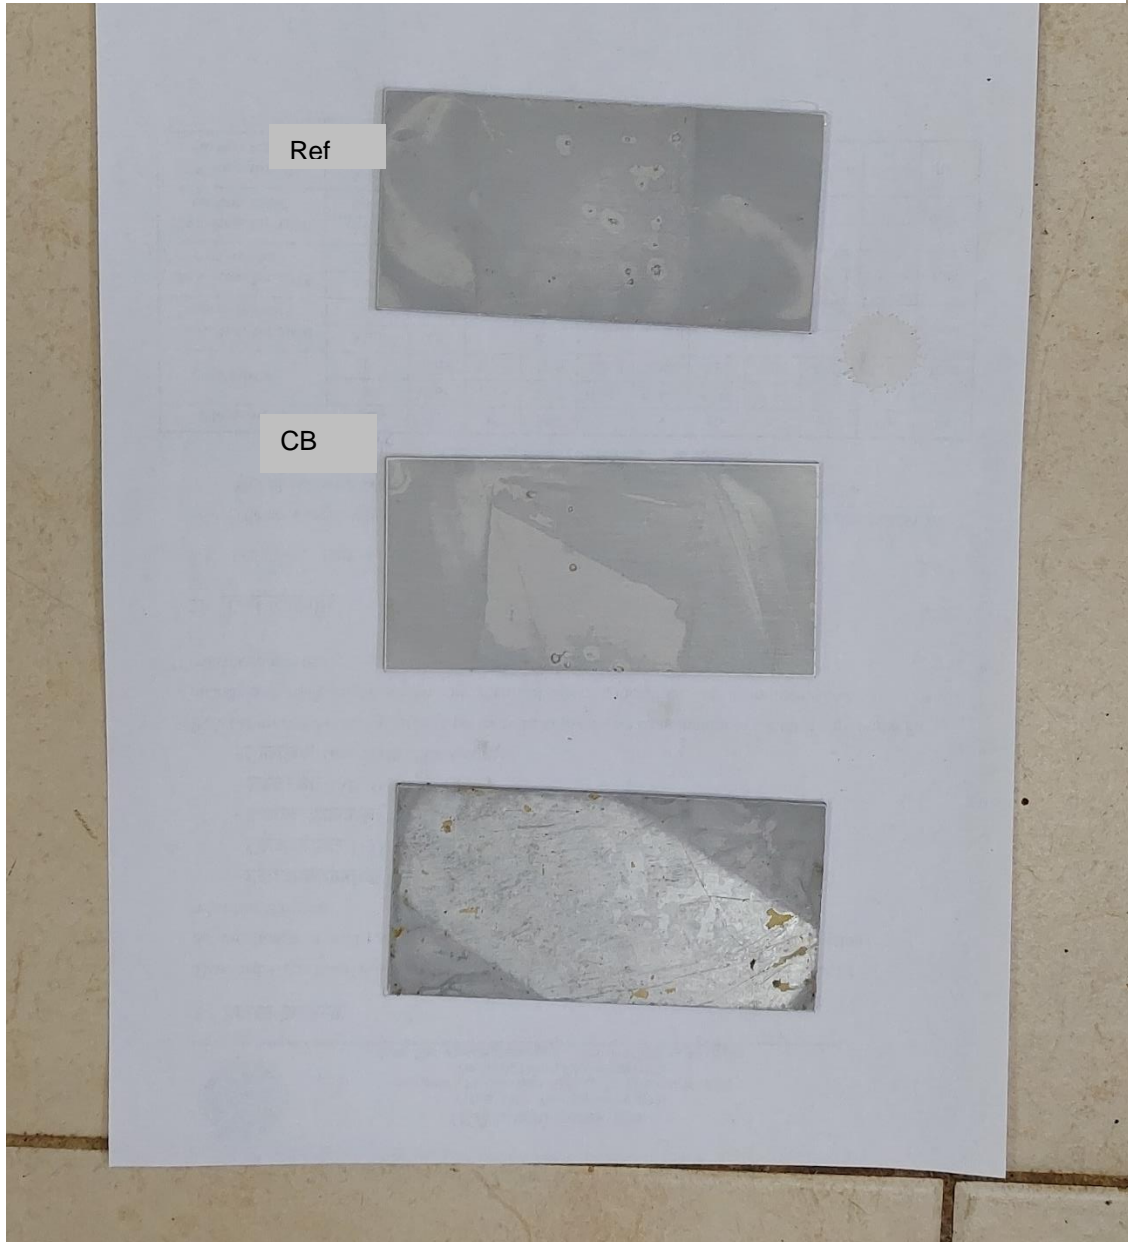
**Figure 5**  
Group V – coupons after 10000 hours of SST and mass loss test  
(CB)"Corrizon Base" treated  
(U) Untreatment  
(Ref) Not treated - reference

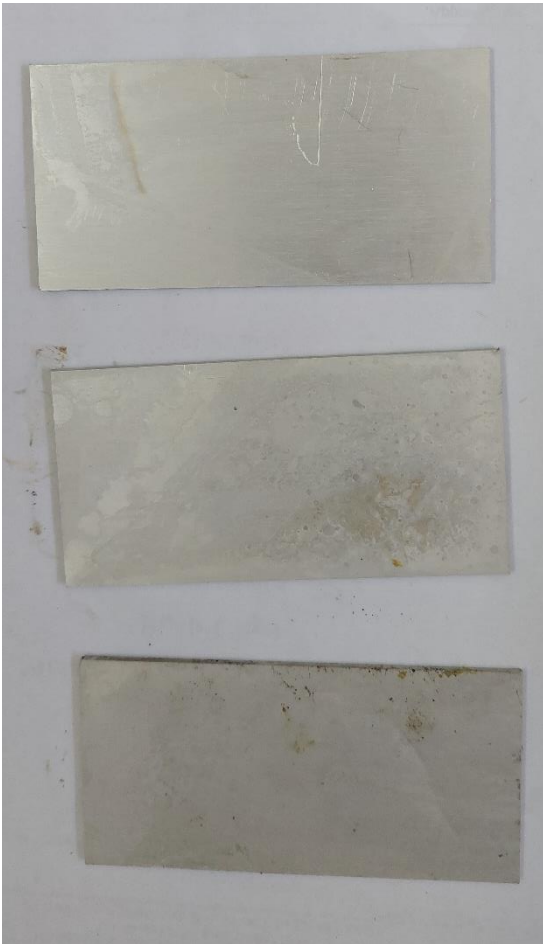
Figure 4

Group III – coupons after 10000 hours of SST and mass loss test

(CB) "Corrizon Base" treated

(U) Untreatment

(Ref) Not treated - reference

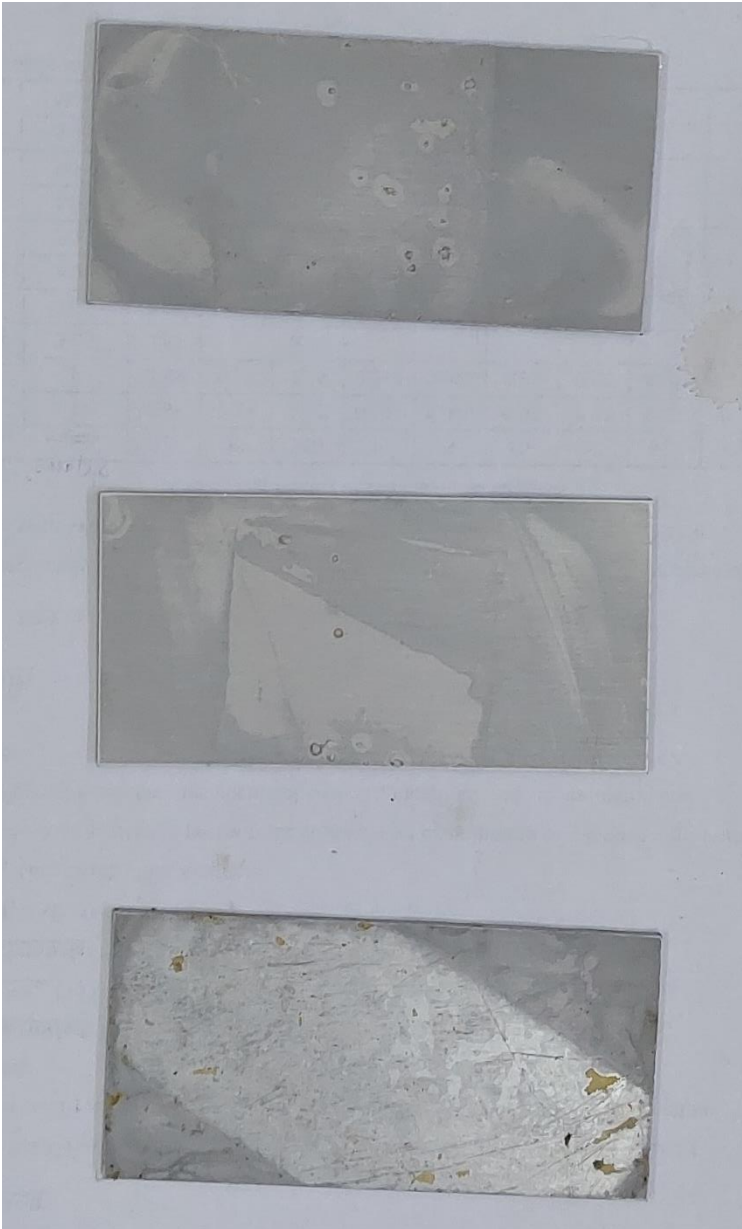
Figure 6

Group VI – coupons after 10000 hours of SST and mass loss test  
(CB) "Corrizon Base" treated  
(U) Untreatment  
(Ref) Not treated - reference

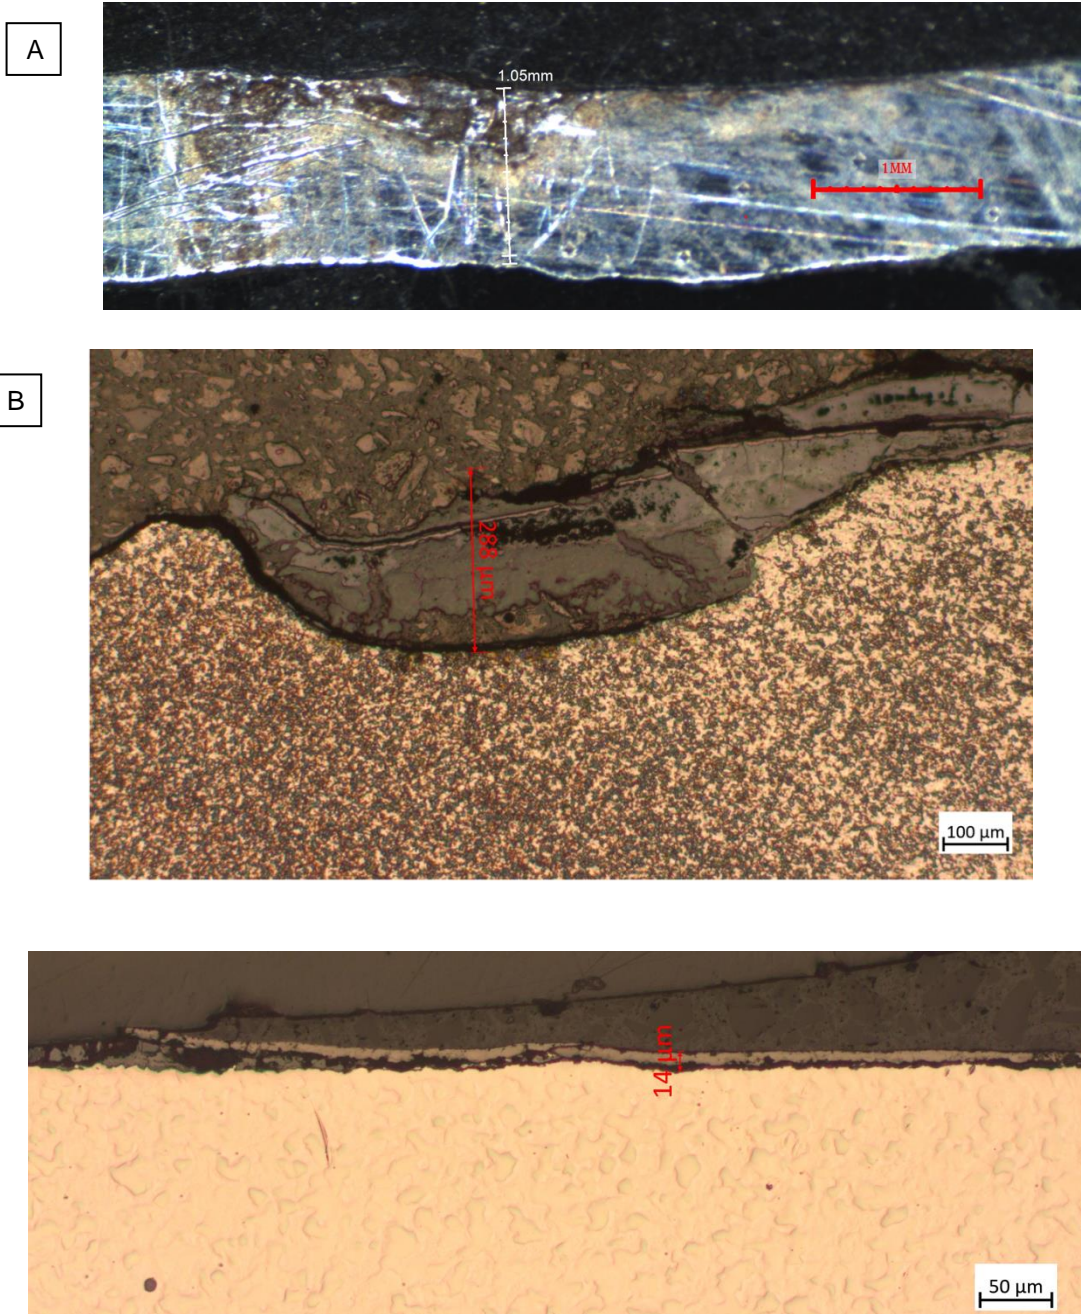
Figure 7. Optical microscope images of metallographic section of the coupons after 10000 hr. in SST

(A) Coupon 114 (St37, not treated)

(B) Coupon 218 (St37 +CB)

(C) Coupon 318 ( St37, galvanized)

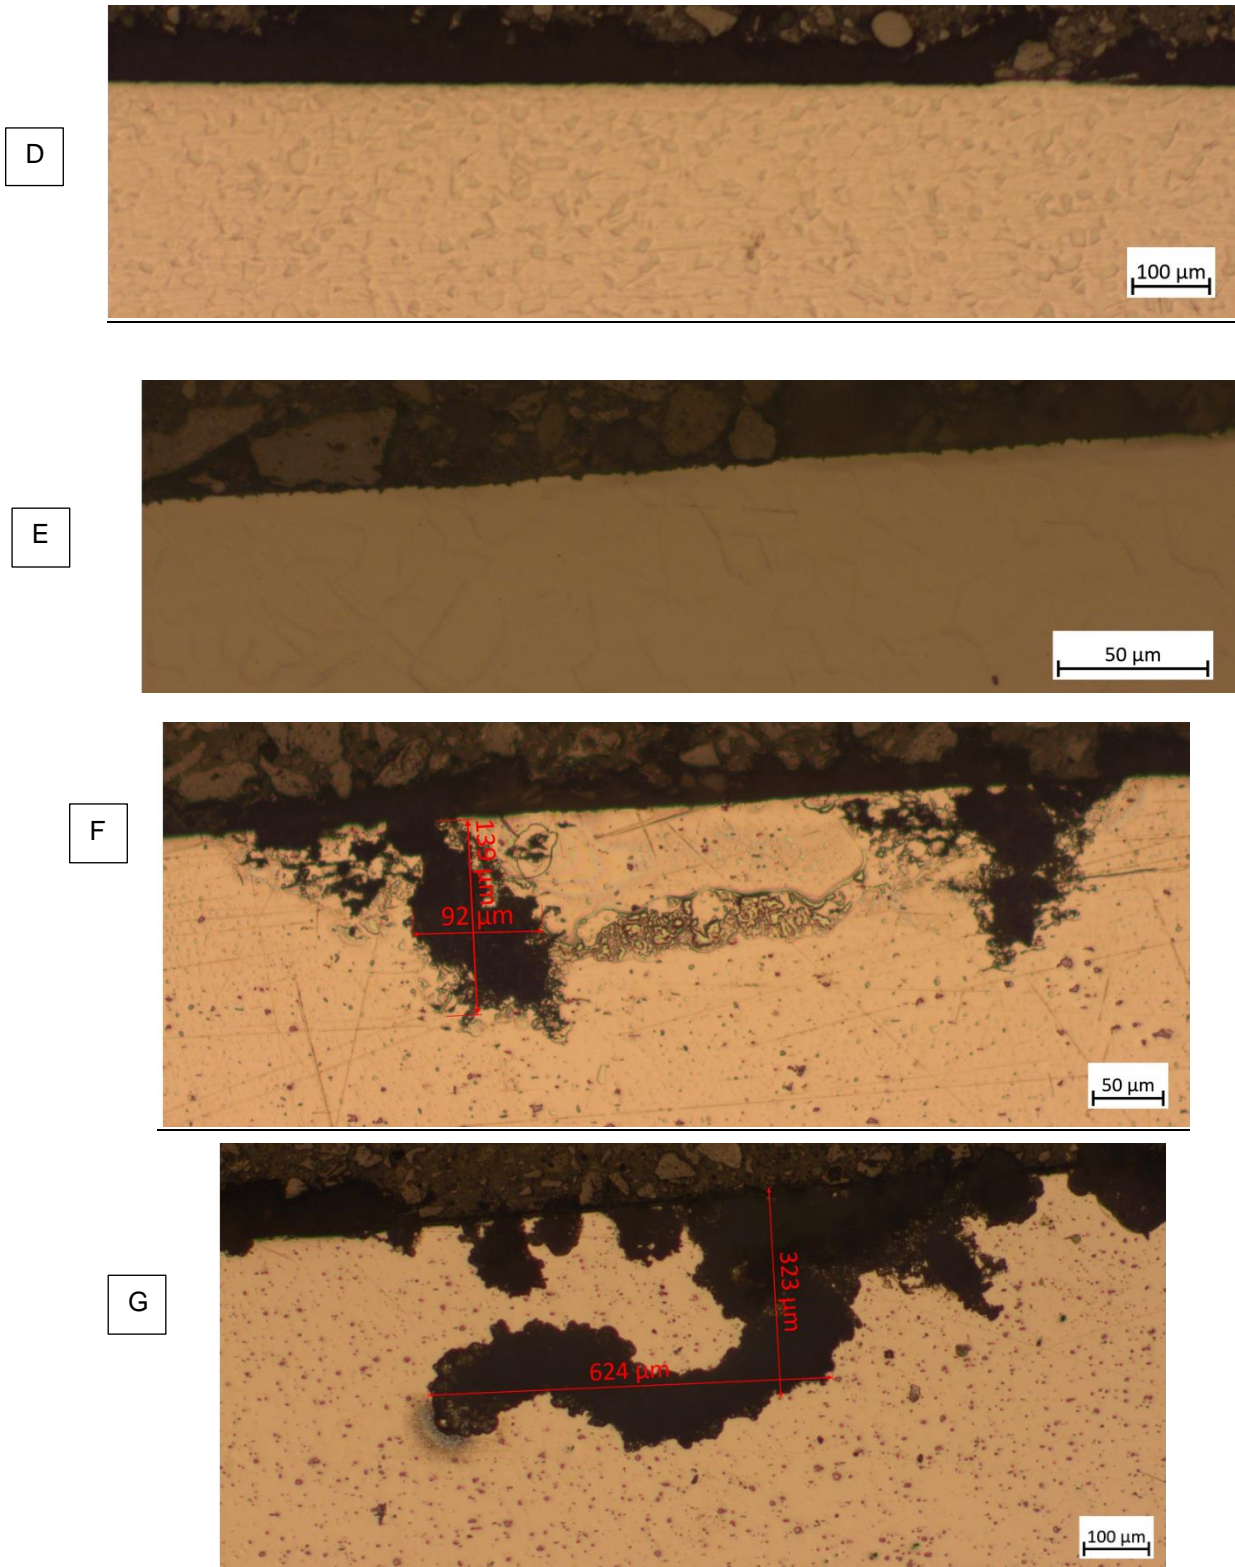
Figure 7(continue).Optical microscope images of metallographic section of the coupons after 10000 hr. in SST  
(D) Coupon 714 (SS304)

- (E) Coupon 832(SS304 +CB)
- (F) Coupon 914 (Al5083)
- (G) Coupon 1014 (Al5083+CB)

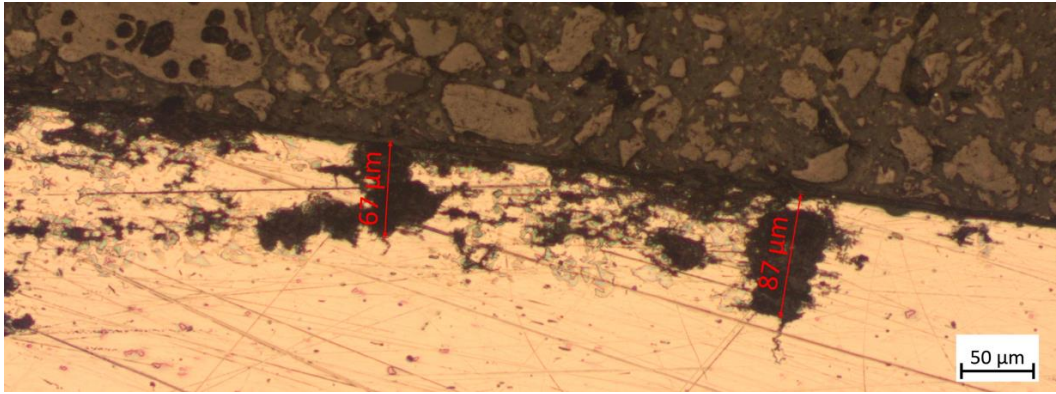
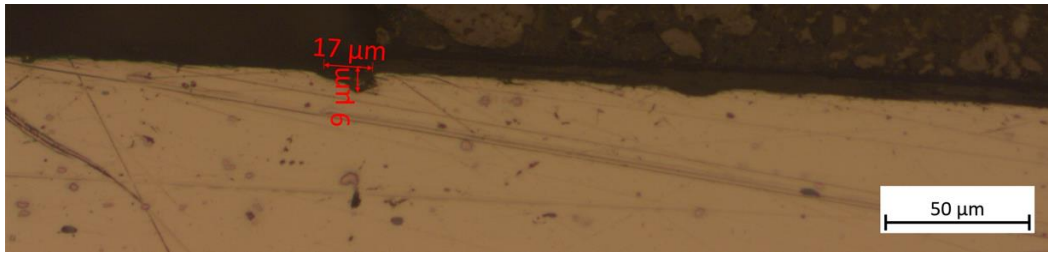
Figure 7(continue). Optical microscope images of metallographic section of the coupons after 10000 hr. in SST

- (H) Coupon 1114 (Al6061-T6 )
- (I) Coupon 1218 (Al6061-T6 +CB)

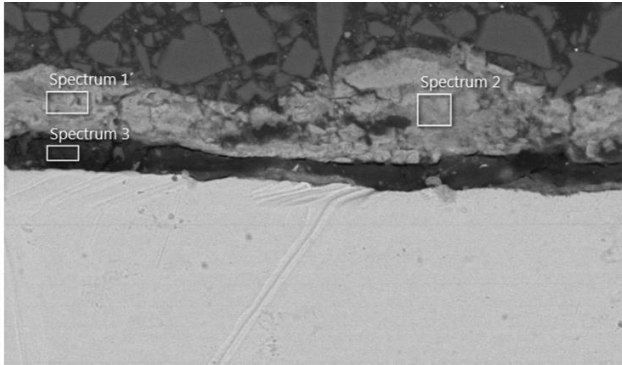
Spectrum 1				
Element	Line Type	Weight %	Weight % Sigma	Atomic %
O	K series	27.67	0.95	56.60
Fe	K series	70.24	0.95	41.16
Si	K series	1.29	0.22	1.50
Cl	K series	0.79	0.16	0.73
Total		100.00		100.00

Spectrum 2				
Element	Line Type	Weight %	Weight % Sigma	Atomic %
O	K series	28.00	0.92	57.17
Fe	K series	70.60	0.93	41.30
Si	K series	0.92	0.22	1.07
Cl	K series	0.49	0.16	0.45
Total		100.00		100.00

Spectrum 3				
Element	Line Type	Weight %	Weight % Sigma	Atomic %
Fe	K series	5.63	0.39	1.44
O	K series	45.81	2.68	41.03
Cl	K series	0.34	0.07	0.14
C	K series	48.00	2.87	57.27
Si	K series	0.22	0.08	0.11
Total		100.00		100.00

**Figure 8. SEM+EDS analysis of metallographic section of the coupons after 10000 hr. in SST  
 (A) Coupon 218 (St37 +CB)**

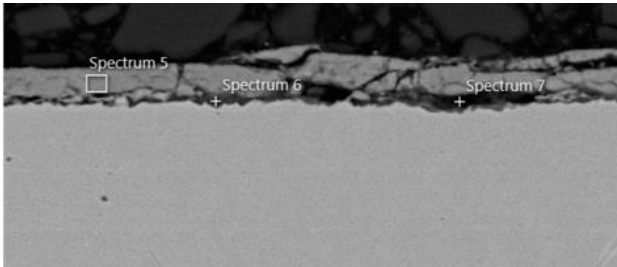
Spectrum 5				
Element	Line Type	Weight %	Weight % Sigma	Atomic %
O	K series	24.60	0.72	53.25
Fe	K series	75.40	0.72	46.75
Total		100.00		100.00

Spectrum 6				
Element	Line Type	Weight %	Weight % Sigma	Atomic %
O	K series	21.57	0.92	47.65
Fe	K series	73.10	0.97	46.26
Si	K series	1.58	0.19	1.99
Ca	K series	0.67	0.10	0.59
Cl	K series	0.35	0.10	0.35
Ba	L series	0.80	0.23	0.20
Na	K series	1.92	0.52	2.95
Total		100.00		100.00

Spectrum 7				
Element	Line Type	Weight %	Weight % Sigma	Atomic %
Fe	K series	84.31	1.27	71.98
Si	K series	10.32	0.58	17.52
Na	K series	4.65	1.28	9.65
Ca	K series	0.71	0.20	0.85
Total		100.00		100.00

**Figure 8 (continue). SEM+EDS analysis of metallographic section of the coupons after 10000 hr. in SST  
 (B) Coupon 318 (St37, Galvanized)**

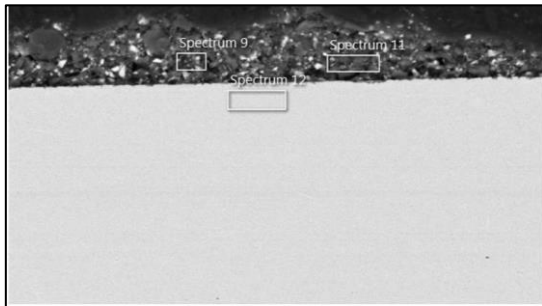
Spectrum 9				
Element	Line Type	Weight %	Weight % Sigma	Atomic %
Al	K series	16.07	0.87	14.49
Si	K series	10.04	0.64	8.70
Ba	L series	21.02	1.09	3.72
O	K series	44.98	2.41	68.39
Fe	K series	2.94	0.34	1.28
S	K series	3.82	0.43	2.90
Cr	K series	1.11	0.25	0.52
Total		100.00		100.00

Spectrum 11				
Element	Line Type	Weight %	Weight % Sigma	Atomic %
O	K series	54.77	0.88	72.70
Al	K series	22.74	0.53	17.89
Si	K series	7.07	0.32	5.35
Ba	L series	10.21	0.39	1.58
Fe	K series	1.90	0.16	0.72
S	K series	2.38	0.23	1.57
Pd	L series	0.92	0.30	0.18
Total		100.00		100.00

Spectrum 12				
Element	Line Type	Weight %	Weight % Sigma	Atomic %
Cr	K series	19.21	0.30	20.18
Fe	K series	70.39	0.45	68.85
Ni	K series	7.72	0.32	7.18
Mn	K series	1.60	0.22	1.59
Al	K series	1.09	0.26	2.20
Total		100.00		100.00

Figure 8 (continue). SEM+EDS analysis of metallographic section of the coupons after 10000 hr. in SST  
(C) Coupon 818 (SS304 +CB)

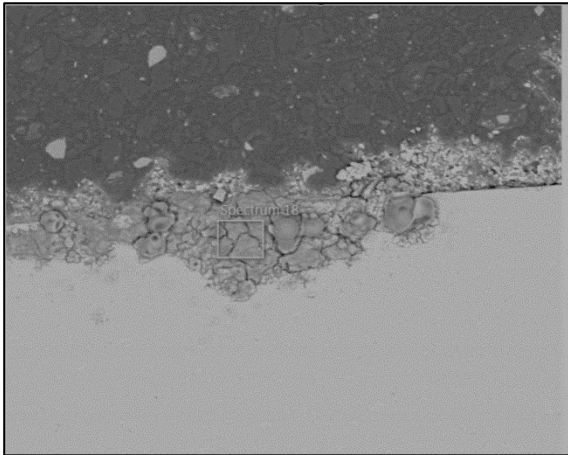
Spectrum 18				
Element	Line Type	Weight %	Weight % Sigma	Atomic %
O	K series	59.10	0.95	71.39
Al	K series	29.54	0.73	21.16
Cl	K series	5.17	0.28	2.82
Si	K series	3.18	0.30	2.19
Mg	K series	1.76	0.28	1.40
Na	K series	1.25	0.37	1.05
Total		100.00		100.00

8 (continue). SEM+EDS analysis of metallographic section of the coupons after 10000 hr. in SST  
(D) Coupon 1019(A15083 + CB)

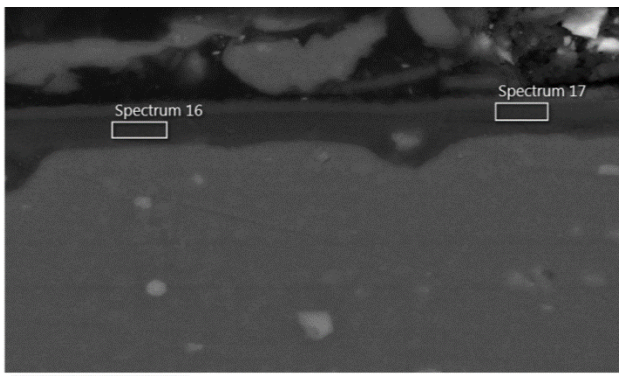
Spectrum 16				
Element	Line Type	Weight %	Weight % Sigma	Atomic %
O	K series	50.24	0.93	62.88
Al	K series	44.60	0.85	33.09
Cl	K series	1.33	0.15	0.75
Na	K series	2.64	0.32	2.29
Mg	K series	1.20	0.23	0.99
Total		100.00		100.00

Spectrum 17				
Element	Line Type	Weight %	Weight % Sigma	Atomic %
O	K series	54.17	0.92	66.47
Al	K series	42.02	0.86	30.57
Cl	K series	0.83	0.14	0.46
Na	K series	2.06	0.33	1.76
Mg	K series	0.92	0.23	0.74
Total		100.00		100.00

Figure 8 (continue). SEM+EDS analysis of metallographic section of the coupons after 10000 hr. in SST  
(E) Coupon 1218 (Al6061 – T6)
